## **AN INVESTIGATION OF REASONS AND CONSEQUENCES OF DETERIORATED HYDRAULIC CAPACITIES OF CULVERTS CONCERNING RAILWAY TRACK STABILITY**

**Niyazi Özgür Bezin**

*Istanbul University – Cerrahpaşa, Turkey*

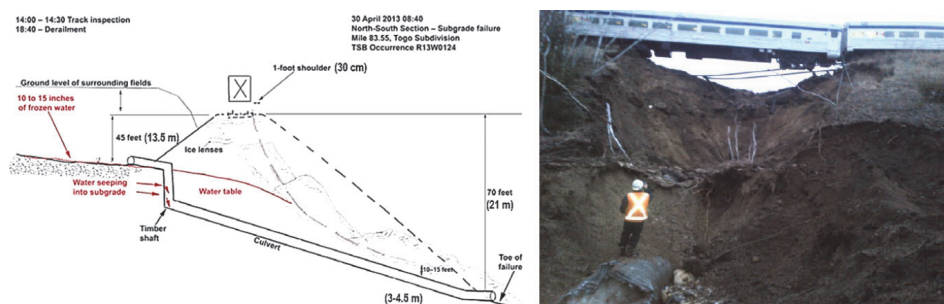
A culvert within a roughly 18 m wide embankment that spanned a ravine failed. The toe of the failure was near the roughly 122 cm diameter culvert shown in Figure 4a. A rapid melt of the snowpack beginning approximately one week before the derailment resulted in a rapid increase in groundwater levels, saturating the embankment. The water within the culvert buried deep within the embankment was relatively insulated from the warming weather and remained frozen. The ice plug at the downstream outlet of the culvert prevented drainage resulting in ponding in the upslope ditch. Figure 4b shows the ice-clogged culvert and the collapsed embankment. Due to the malfunctioning culvert, the accumulating waters along the upstream face of the embankment forced the embankment to work as a dam, which was a function that it was not designed for. The increased hydraulic head in the culvert barrel and the vertical shaft structure seeped the water due to accumulating pressures into the embankment. The north face of the embankment was also covered with phreatophyte vegetation, which thrives in areas where the soil is saturated or in groundwater discharge areas.

**Figure 4** a) Embankment profile showing the clogged and seeping culvert, b) View of the collapsed embankment from the toe of the culvert [10]

The embankment was evaluated and was found to have high shear strength and was not prone to failure if adequate drainage was maintained. The routine track inspections also failed to identify the blocked drainage system due to the inaccessibility of the culvert to routine track inspections. The crew observed a 3 m portion of ballast missing under the track, just ahead of the train, and placed the train into emergency braking.

Although immediate action was initiated, the range of vision available to the crew did not allow sufficient time to stop the train before reaching the affected area. As the train traversed the unsupported portion of track, the embankment collapsed further beneath the weight of the train, leading to the derailment shown in Figure 4b.

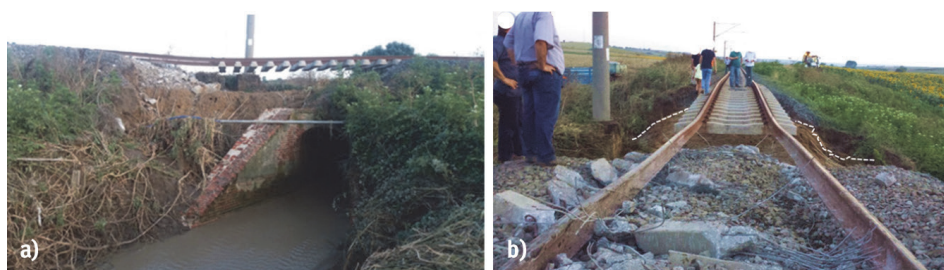
On July 8, 2018, a passenger train that was carrying 362 passengers along the Uzunköprü-Halkali Regional line between the cities of Edirne and Istanbul, derailed, killing 24 passengers and heavily injuring 42. The cause of the derailment was the failure of a clogged culvert under the overflows and the scour of the embankment surrounding the culvert [11].

The estimated 150-year-old masonry culvert could not provide drainage for the approaching upstream flow rate that was multiple times the flow rate the culvert could have supported and provided passage underneath the railway track. The excessive flows flooded the culvert and overran the railway line. However, the real damage began as the flood waters began to scour the embankment soil around and above the culvert. The washout of the soil above the culvert undermined the railway track which led to the loss of the track superstructure above the culvert. In an instant, a part of the ballasted railway track was completely washed away with roughly 12 m [35 ft] of track panel suspended about 45 cm (1.5 ft) above the culvert. Figure 5a and 5b shows the undermined track and the collapsed embankment. The fill surrounding the culvert was weakened by random wild plant growths, the large roots of which created planes of weakness within the embankment slopes. Unlike, special species of grass-type vegetation, wild vegetation with deep and large roots is detrimental to the stability of the embankment soils [12, 13].

Figure 5 a) Undermined railway track and the (b) collapsed embankment [11]

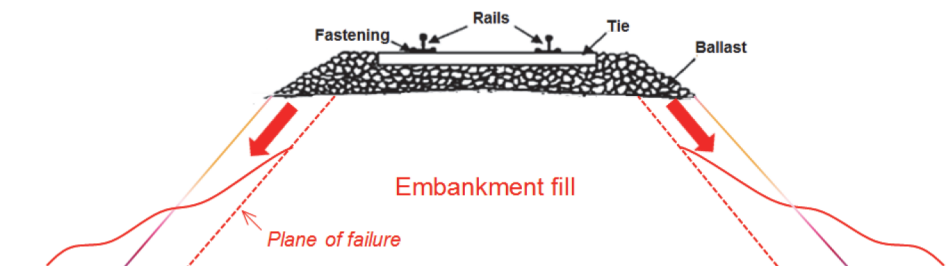
One particular problem with this railway route was the insufficiency of the embankment width. Outer layers of saturated embankment, slipped along these planes, dragging along the upper ballast layers for the railway track. Figure 6 depicts the developed failure on the embankment that can be correlated to image on Figure 5b. The accumulated water pressure on the southern side of the culvert pushed the remaining ballast layers towards the north thereby undermining the railway track panel composed of ties and rails. The passenger train approached the undermined region towards Istanbul at about 110 km/h. The machinist could not have seen the damaged track ahead and responded to stop the train. The locomotive passed over the undermined region with an intensive impact followed by the derailment of 5 of the 6 trailing wagons

Figure 6 Embankment failure that led to superstructure failure
