## RECONSTRUCTION OF THE JARUNSKA ROAD IN ZAGREB AFTER THE EARTHQUAKE

Miroslav Šimun, Ante Goran Bajić, Davor Marković, Luka Jurčević

### Abstract

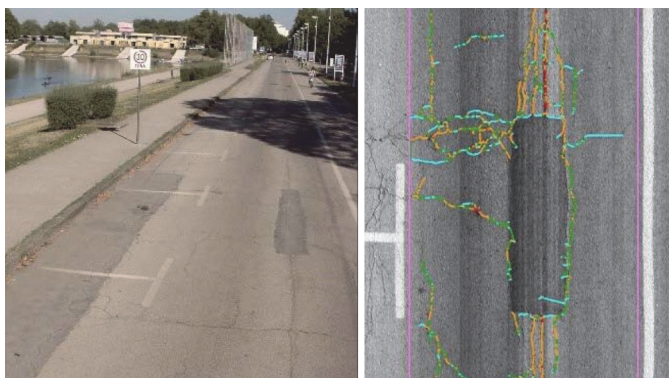
**Figure 1** Damage on the pavement of Alley Matija Ljubek [2]

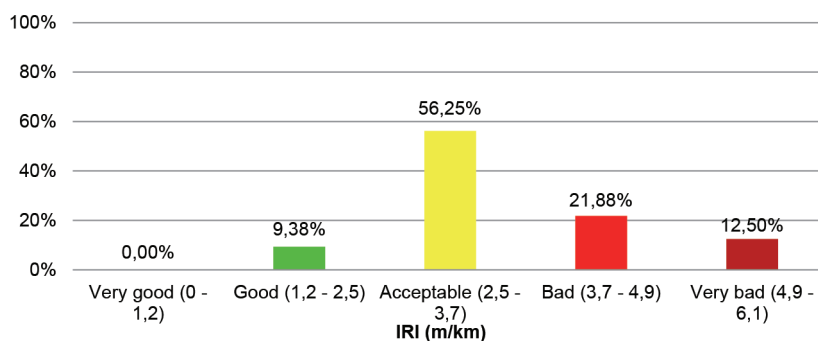
Graphically, the determined values of IRI are divided in five groups. It is evident that the largest share from 56.25% of the findings, falls within the secondary group. This indicates the need for pavement reconstruction to prevent further increases in inequality (Figure 2).

Figure 2 Distribution of IRI values by intervals

According to Table 2, subject Aleja Matije Ljubek road falls under the category of class III city roads. It is visible that the tolerable marginal index equality ( $IRI_t$ ) corresponds to the borders between the group values IRI 'good' and 'acceptable', as depicted in Figure 2. Considering that measured values of IRI exceed the acceptable borderline values, everything indicates a clear need for renovation of the roadway.

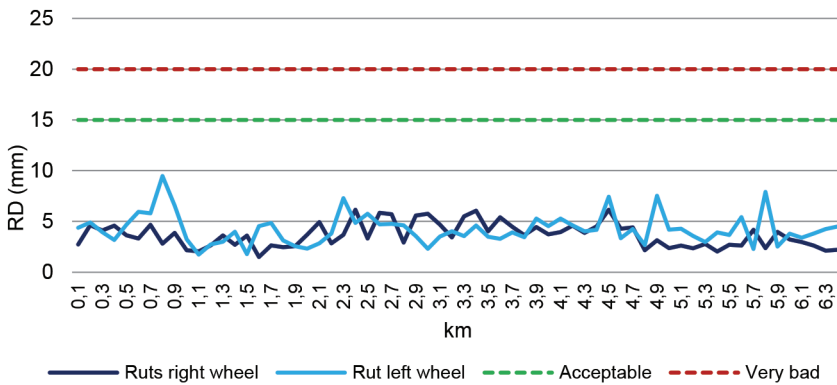
For the analysis and renovation of the road around Lake Jarun, depth and the form of the route have been established along the entire route roads. Measurements are carried out with the help of a string laser attached to trace wheels positioned on a measurement beam. The lasers measure the depth of rut and determine the width and form of the route. In Figure 3, values of rut depth for the left and right trace wheels are shown in relation to the acceptable rut depth threshold. The rut depths are satisfactory, as both tracks’ wheels maintain uniformity along the entire length of the routes and significantly below the prescribed limits. The average rut depth is below 5mm.

The good condition of the driving surface roadway, particularly with consideration to the depth of rut, can be attributed to the fact that the road doesn’t experience difficult traffic, mostly consisting of personal cars.

Figure 3 Measured values of the rut depth of the road surface

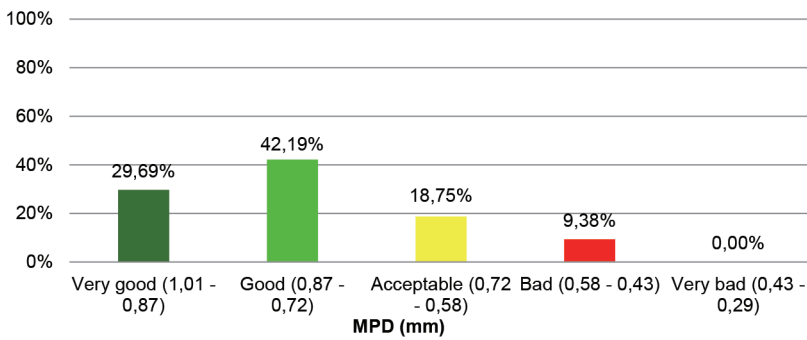
The measured values of macro textures are divided into five groups using values from Table 3 (Figure 4). Group 'very good' and 'good' macrotexture contains 72% of the measured values which indicates a good macrotexture roadway on Aleja Matije Ljubek.

Figure 4 Depths of macro textures on road driving surfaces per groups

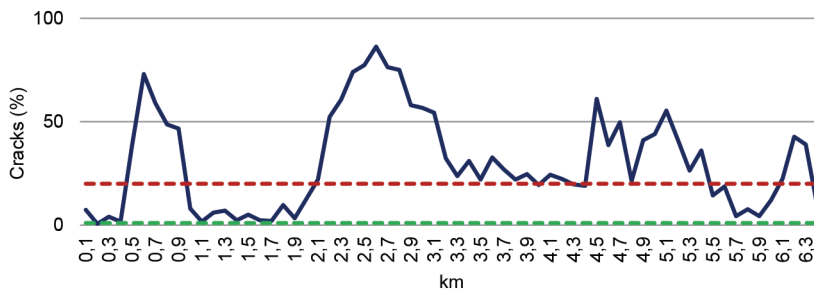
Cracks on Aleja Matije Ljubek are measured using a system with automatic crack detection, equipped with spectral cameras and lasers to determine the shape of the cracks. This system operates entirely automatically, capturing continuous sections of the roadway in one pass, and then analyzing and processing the data shown in Figure 1 (right). Cracks are classified according to their size, scope and type. Throughout the entire length of the driving surfaces, there is a noticeable percentage of crack occurrences above borders of acceptability, indicating a high level of pavement degradation (Figure 5). Specifically, 67.19% of the roadway surfaces falls within a group with a crack share exceeding 15%, which belongs to the 'very bad' condition of the driving surface. The average crack share in surface roadway for the group 'very bad' amounts to 42.23%, negatively impacting pavement roughness and accelerating the deterioration of the roadways constructions in the winter period due to the process freezing and defrosting.

Figure 5 Cracks percentage in road surface

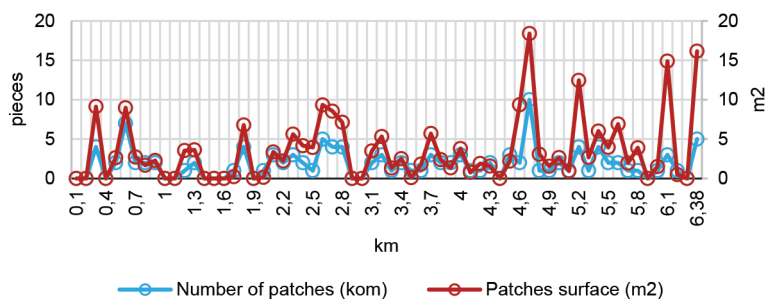
According to the Rulebook on road maintenance [9], patching involves repairing the road surface by making cuts in a rectangular form, parallel with the central line of the roadway with a minimal thickness of 50 mm. The final repair should not extend wider than the surrounding roadway and should not effect on drainage. The acceptable percentage of the patched area on the road surface is 0.3%, while exceeding 1% indicates a very bad state. Patching has been performed along the entire length of Jarunska road, with the patched area exceeding the acceptable value. In the last third of the road, it even exceeds border and height acceptability. The intensity of patching varies along the tracks, from the fourth kilometer to the end of the roadway the total of damaged surfaces intensifies and number of patches increases (Figure 6).

**Figure 6** Patches on pavement
