THE SHOULDER OF THE NEIGHBOURING COUNTY IS ALWAYS “GREENER”

Abstract

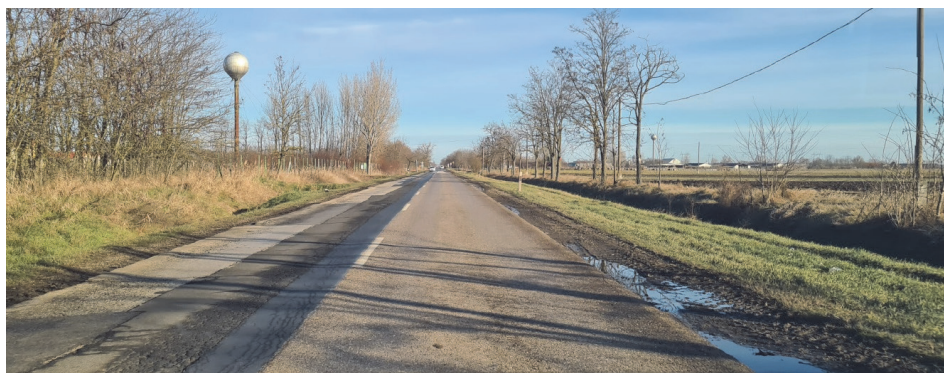
The design of road shoulder has to be planned based on transversal (cross) fall and its load bearing capacity may vary depending on the role (significance) of the road in question. Nowadays, on newly built 2x1 lane roads, a wide stabilized bench is designed in Hungary so that driving off the road pavement surface does not cause an accident with a serious outcome. The internal regulations, the relevant Technological Specification [1] describe the two most important shoulder maintenance activities. In addition to high-volume mechanized works, manual shoulder maintenance operations are also regulated [2] and beyond these, the geometrical requirements and material of the road slope, as well as their maintenance works are specified. The two main types of shoulder failure/deterioration are rutting and blow out (Figure 1).

Figure 1 Typical failures of road shoulders - on the right, rutted, too wide shoulder with improper fall; on the left, blown up shoulder (Photo: Zsolt Bencze)

The deterioration of the road section shown in Figure 1 can clearly be explained by the defective shoulder. If this maintenance intervention was carried out in time, the service life of the pavement structure would be 15 years, in addition to the planned traffic volume increase. It can be easily seen that, at the current construction prices, the national economic costs coming from resurfacing, continuous pothole repair and additional maintenance works are orders of magnitude compared to the main-tenance costs of a shoulder and a roadside ditch.

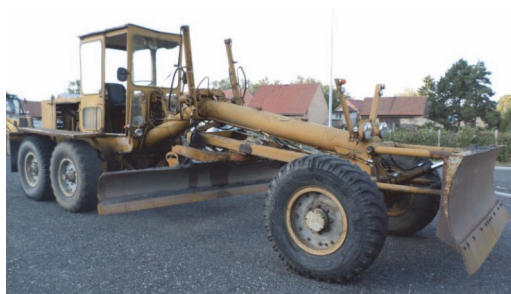
The two most important shoulder maintenance techniques: shoulder milling and shoulder reshaping, requiring different machines. In the former case, grader (Figure 2.), while in the latter one, a special target machine - a self-propelled shoulder milling machine (Figure 3.) is used as the control machine in Hungary. In addition to the shoulder, repairing the drainage ditches can be considered also as an important technological step, since the completion of only one element (just the repair of poor shoulder leaving the bad quality of roadside ditches or profiling the ditches without repairing road shoulder), cannot ensure the expected improvement in the service life of pavement structure [3].

Figure 2 A grader used by Hungarian Public Road Non-Profit Liability Company (Photo: Csaba Tóth)

The technology of the shoulder maintenance by cutting has been used for a long time and is widespread in Hungary. In addition to the road grader (70 machines are in use by the MK - their average age amounts to 34 years), its machinery needs are: loading machine, transport vehicles, vehicle equipped with sweeper adapter, brigade transporter(s), if necessary, vibratory roller, shoulder roller [4].

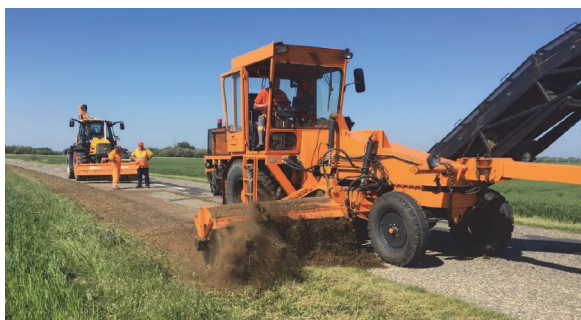
Figure 3 Madro SP-1500 shoulder milling machine in work (Photo: Csaba Tóth)

There is no significant practice of milling maintenance in the Hungarian road engineering. Only the operator firm of state public roads has 5 single-purpose machines and 2 adapter-type devices that can be mounted on a universal device carrier. Shoulder maintenance by milling has been a technology used in Hungary since 2003. Due to the small number of single-purpose machines, this technology is not widespread. Its machinery requirements in addition to the shoulder milling machine itself: transport vehicles, a vehicle equipped with a sweeping adapter as needed, brigade transporter(s), vibratory roller, shoulder roller.
