## EFFECT OF CRACK SEALING TREATMENT ON SKID RESISTANCE OF PAVEMENT

*Slovenian National Building and Civil Engineering Institute, Ljubljana, Slovenia*

### Abstract

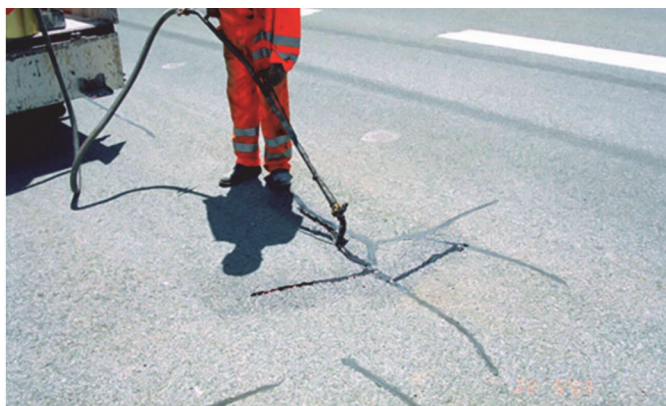
Figure 1 Crack sealing with bituminous sealing compound

However, skid resistance is rarely measured in literature. Our study focused on differences in conditions before and after such treatment, based on the assumption that skid resistance of pavement could be reduced due to crack sealing treatments. The results of the study also help road owners evaluate the risks associated with changes in skid resistance due to crack sealing. In the literature, we found only one similar study [4, 5], where Locked-Wheel Skid Tester (LWST) testing was conducted on several pavement projects in North Carolina, United States, with varying amounts and patterns of crack sealant. It was established that the application of high amounts of crack sealant to the wheel path can pose safety hazards.

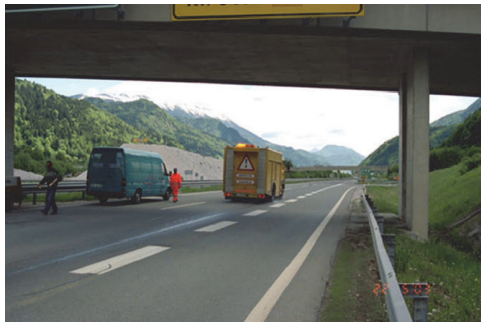
**Figure 2** The SCRIMTEX device was used to measure the average effect on the overall skid resistance of the entire road surface

Skid resistance was measured using the British pendulum apparatus (SRT - Skid Resistance Tester) [6] and the SCRIMTEX device [7, 8]. The SCRIMTEX device was utilized to gauge the average effect and overall skid resistance on the pavement surface of the entire test section (see figure 2). The SCRIMTEX device is a Sideway-force Coefficient Routine Investigation Machine (SCRIM) equipped with sensors for measuring texture depth. A free-rolling measuring wheel with a tire lacking a profile is mounted on the frame of the measuring mechanism, approximately in the middle of the vehicle (viewed longitudinally). A known weight applies vertical pressure on the measuring wheel, which rolls along the right wheel track at a  $20^\circ$  angle to the direction of travel. Just ahead of the measuring wheel, we wet the carriageway with a controlled jet of water, simulating unfavourable conditions on the road surface. The pendulum was utilized to conduct measurements directly on sealed cracks (see figure 3) and also to compare the skid resistance of the asphalt surface near the sealed cracks with that of the sealed cracks themselves. Measurements were taken at three different locations, each with an average length of about 0.5 km. According to national regulation for measurements using the SRT, results below 50 SRT units indicate poor condition of the road pavement surface.

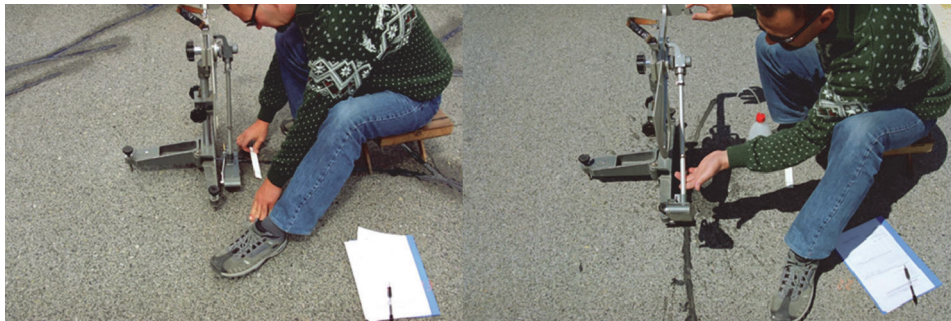
**Figure 3** The SRT was used to measure directly on the sealed crack in both the transversal and longitudinal direction

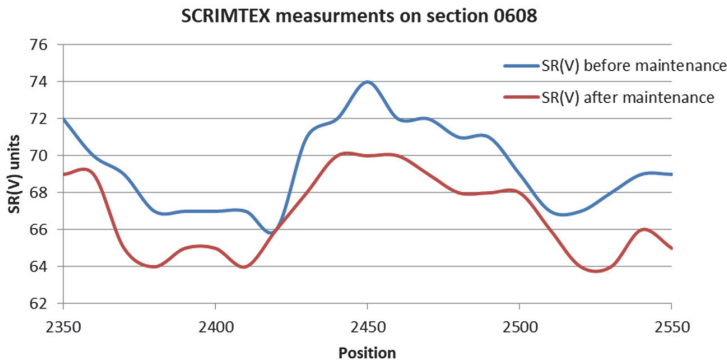
Figure 4 Measurements with the SCRIMTEX device

Table 2 and Figure 4 show measurements taken with the SCRIMTEX device. It can be seen that the difference in skid resistance of the entire road section before and after crack sealing treatment is small yet significant. The measurement results indicate that intensive crack sealing treatments reduce the skid resistance of the entire road surface. Results are expressed in SR values, measured in the nearside wheel path.

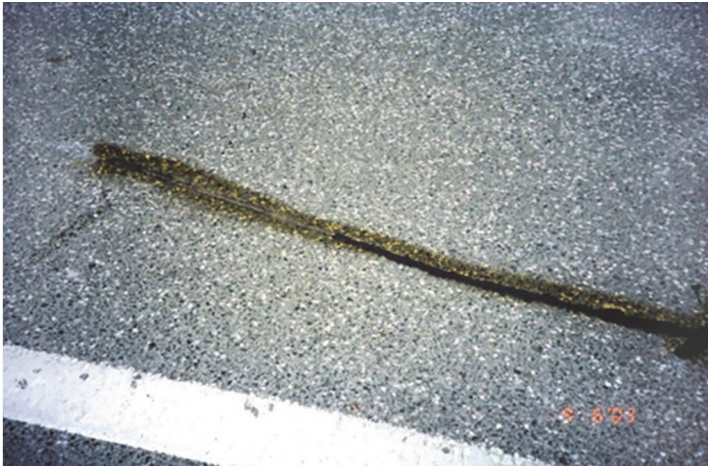
Figure 5 Light Expanded Clay Aggregate (LECA) on the surface of the left part of sealed crack

LECA is porous ceramic product with a uniform pore structure, typically resembling a potato or round shape due to the circular movement of the klin. Its lightweight and thermal and sound isolation properties stem from the numerous small, air-filled cavities within the material. The objective of the trial was to enhance the skid resistance of the cracks. The density of LECA granules (2/4 mm) is approximately 0.5 g/cm<sup>3</sup>, and they adhere to the surface of the liquid sealing compound. Even after the compound hardens, the granules continue to protrude from the surface, as shown in figure 5.
